Manhole Inspection Summary

Manhole # S27S__018MH

Location Address: **1600 Bayard St**

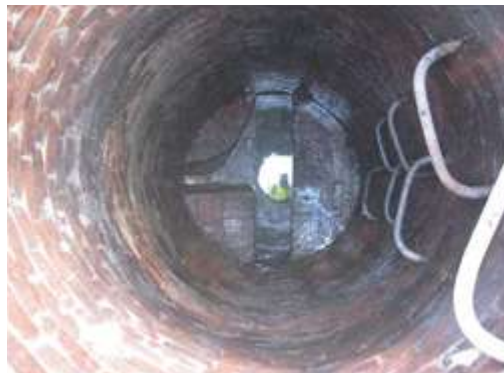
Top View

Main channel is running above spring line into 36" pipe

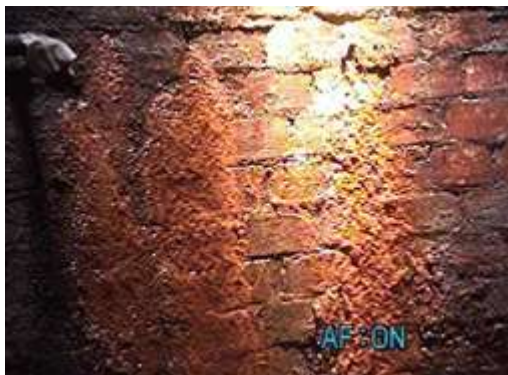
Defect 4

Infiltration: ☐ None ☐ Joint ☐ Cracks ☐ Mortar ☐ Roots ☒ **Wall**

signs of infiltration in barrel

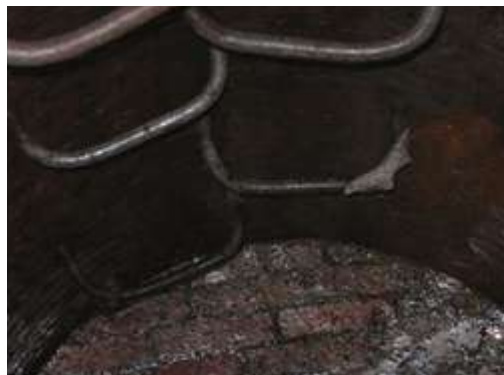
Defect 3

☒ **Evidence Of Surcharge** Depth: **0** (ft.) ☐ Active Surcharge Present

signs of surcharge

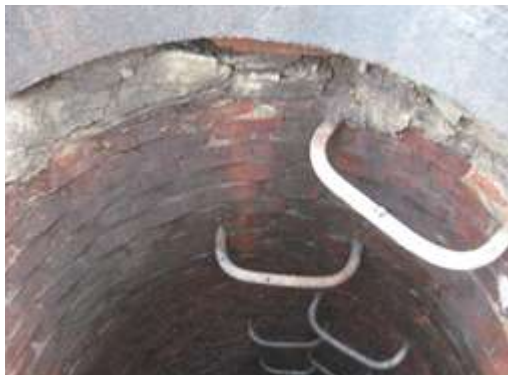
Defect 2

Condition: ☐ Sound ☐ Cracked ☒ **Leaks**

Condition: ☐ Sound ☐ Cracked ☐ Root Intrusion ☐ Loose Brick ☒ **Deteriorated**

deteriorated chimney, signs of infiltration
frame/chimney
